INSTALLATION RESTORATION PROGRAM

Addendum to the
Phase I Records Search

For Air Force Reserve and
Air National Guard Facilities at
General Billy Mitchell Field
Milwaukee, Wisconsin

November 1986

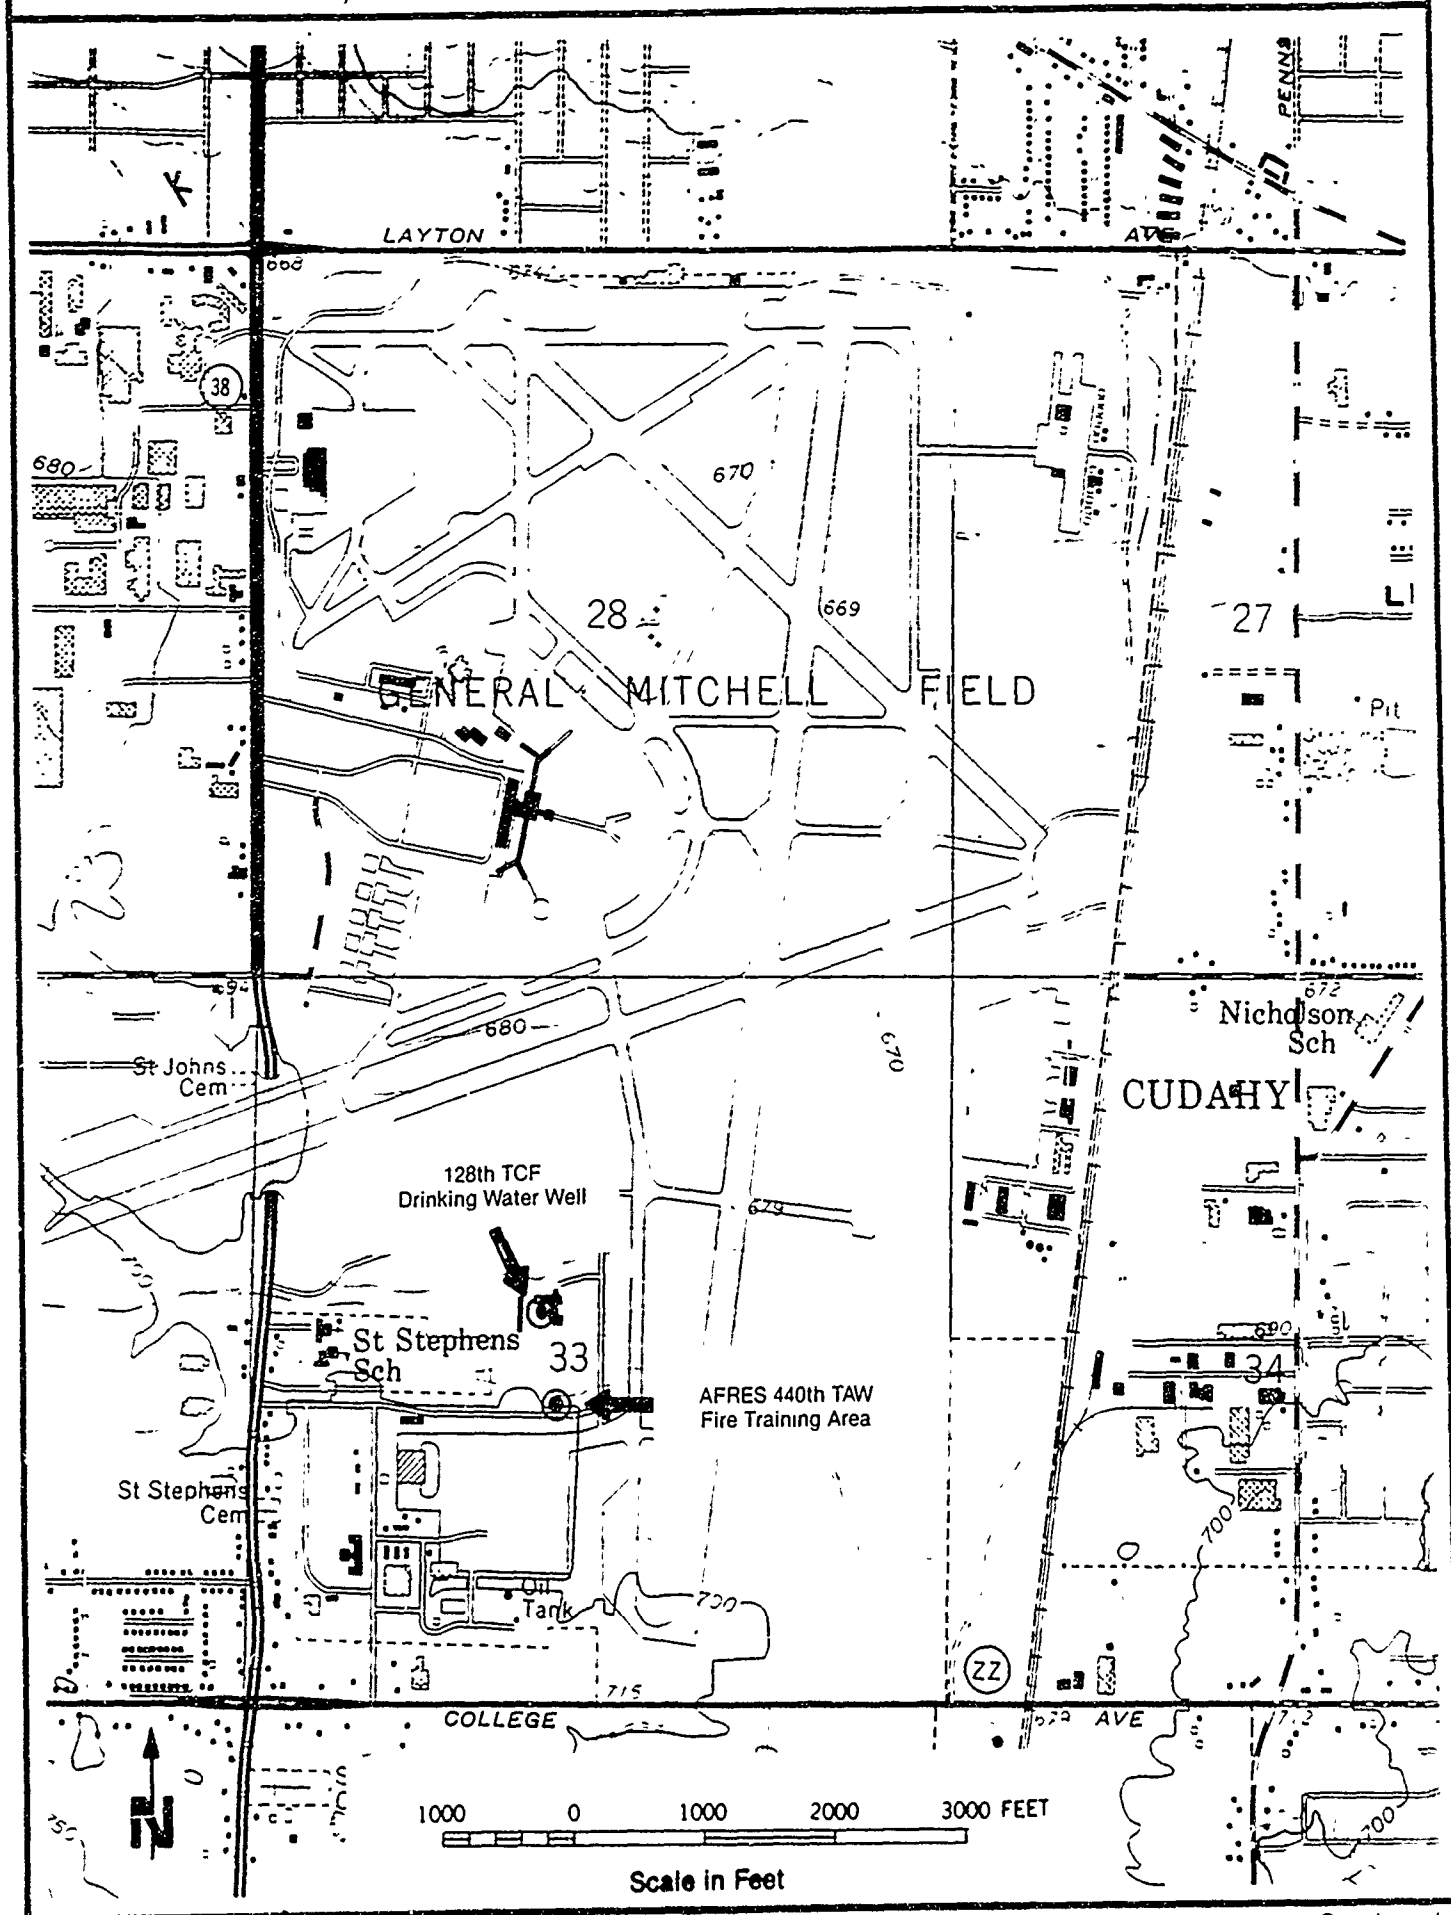
Figure 2.

Location of AFRES FTA and Wisconsin ANG 128th TCF Well at General Mitchell Field, Milwaukee, Wisconsin.

The 128th TCF obtains drinking water from a well located in Building 301 (see Figure 2). Analysis of 128th TCF well water samples shows contamination by low levels of chlorinated organic compounds. Sampling analysis reports for this well are found in the appendix of this addendum. No contaminant spills are reported to have occurred at the 128th TCF to account for the presence of these contaminants. However, the well is located approximately 500 feet topographically downgradient of an operating fire training area (FTA) used by AFRES (see Figure 2).

AFRES fire training operations are described in the Weston Report however, mention of an active downgradient well is omitted. JP-4, spent solvents and other flammable hazardous materials have been routinely released into this FTA, which has been in operation since the activation of the AFRES facility in the 1940s. During the 1960s and 1970s, an area adjacent to the FTA was used as a hazardous waste storage site. Since 1980, AFRES reconstructed the FTA installing berms and a concrete pad. HMTG visited FTA during a rainstorm. At this time, rainwater was running over the berm and onto the surrounding gravel. Prior to 1980, the AFRES FTA consisted of a clay lined pit. The Weston Report questioned the integrity of the pit's clay liner.

An additional environmental concern identified involves the operating well located at the 128th TCF, and its proximity to the AFRES FTA. Although there is no direct evidence of contaminant migration from the FTA to the well through groundwater, it is a potential environmental risk which should be investigated. It is recommended that this well be sampled on a regular basis and analyzed for petroleum hydrocarbons, and aromatic and halogenated volatile organics. The FTA has been identified as a site and HARM Scored in the Weston Report. Thus, IRP Phase II investigations will be undertaken at the FTA in the future by AFRES.

Thorough characterization of the potential for contamination of the 128th TCF well would require a detailed study. It should be noted that there are numerous industries in the area surrounding Billy Mitchell Field. It is possible that these industries may use and discard chlorinated organic compounds. However, determination of the precise source of groundwater contamination is beyond the scope of this addendum. AFRES is initiating IRP Phase II activities in the vicinity of this well. Phase II investigations are to confirm the presence of groundwater contamination, and if contamination is present, to identify the source and direction of the contaminant plume.

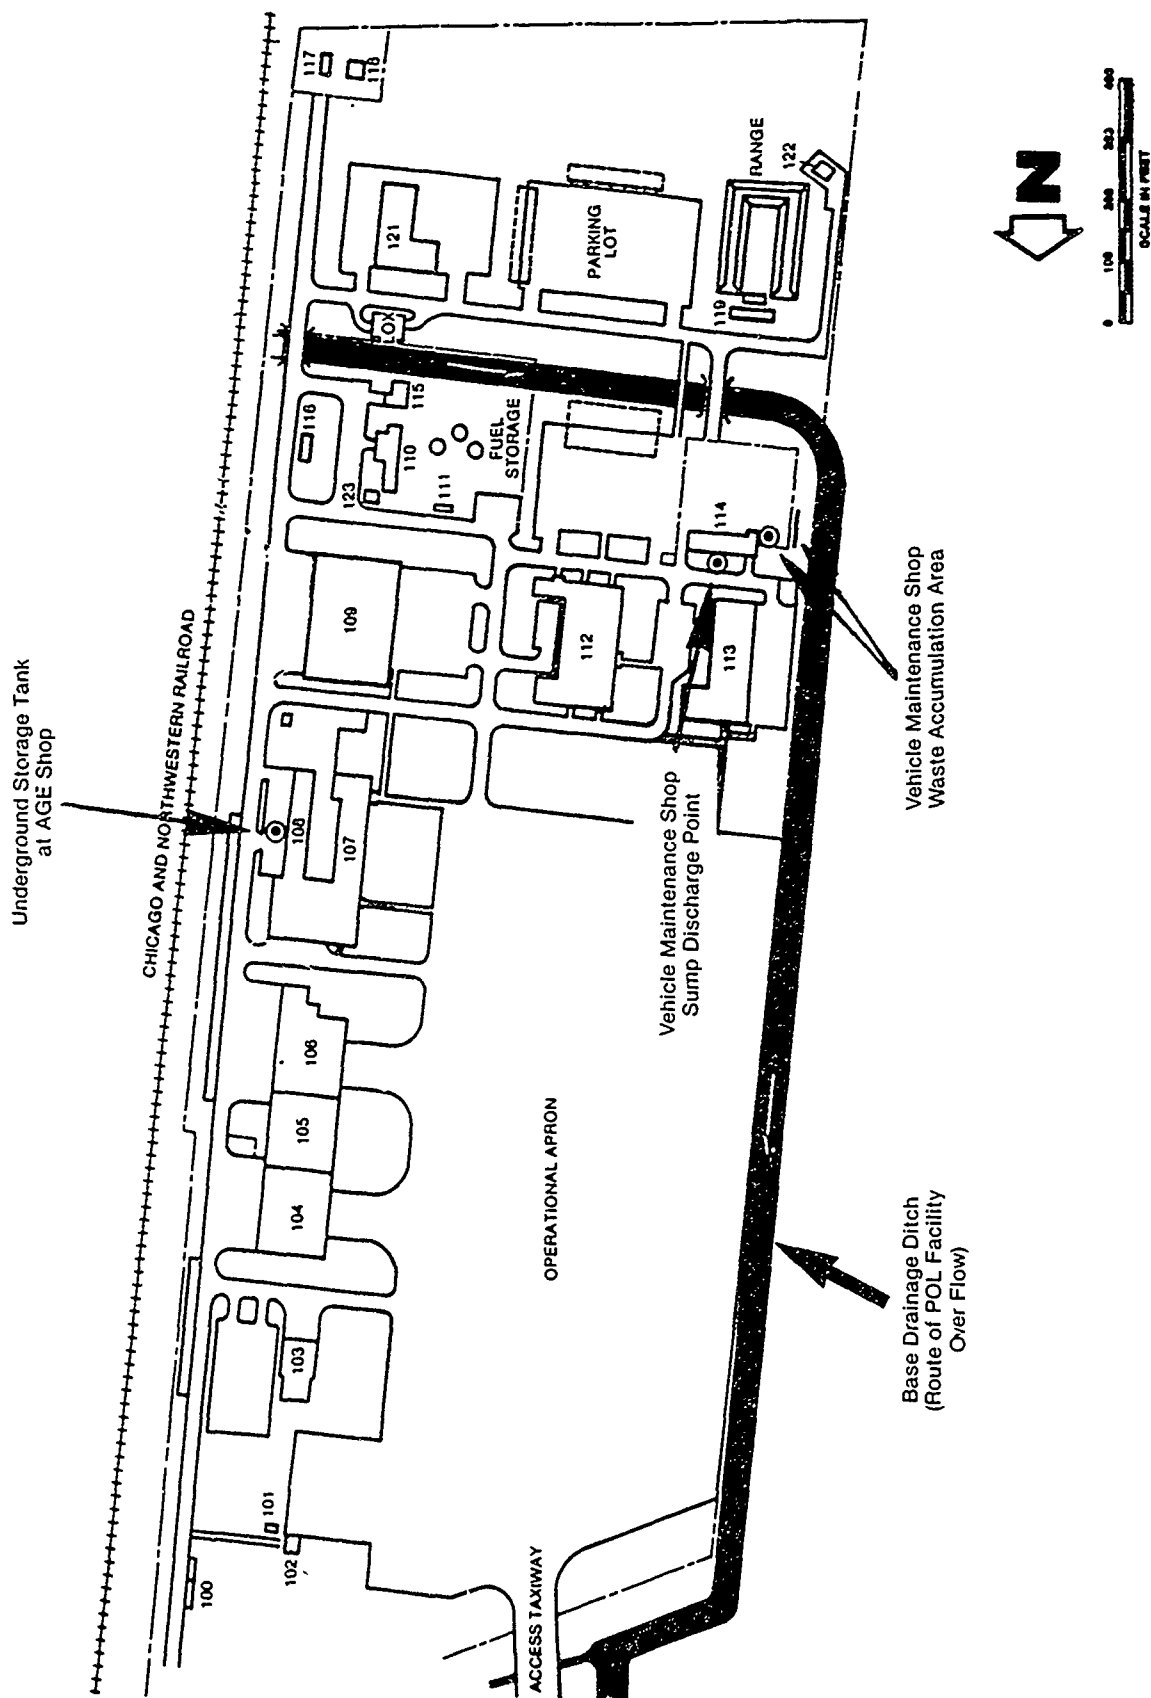
Figure 3.*

HMTC reinterviewed personnel at the 128th ARG, and conducted shop visits and site tours. Except for a few instances, current hazardous waste management practices at the General Mitchell ANGB are as described in the Weston Records Search. HMTC also interviewed personnel and conducted site tours at the 128th TCF portion of General Mitchell ANGB. 128th TCF operations were not addressed in the Weston Report. The activities of the 128th TCF, and instances at the 128th ARG where waste management practices vary from those described in the Weston Report, are described below. Locations of sites referred to below are indicated in Figures 2 and 3.

Locations of Environmental Concern
at General Mitchell Field ANGB, Milwaukee, Wisconsin.

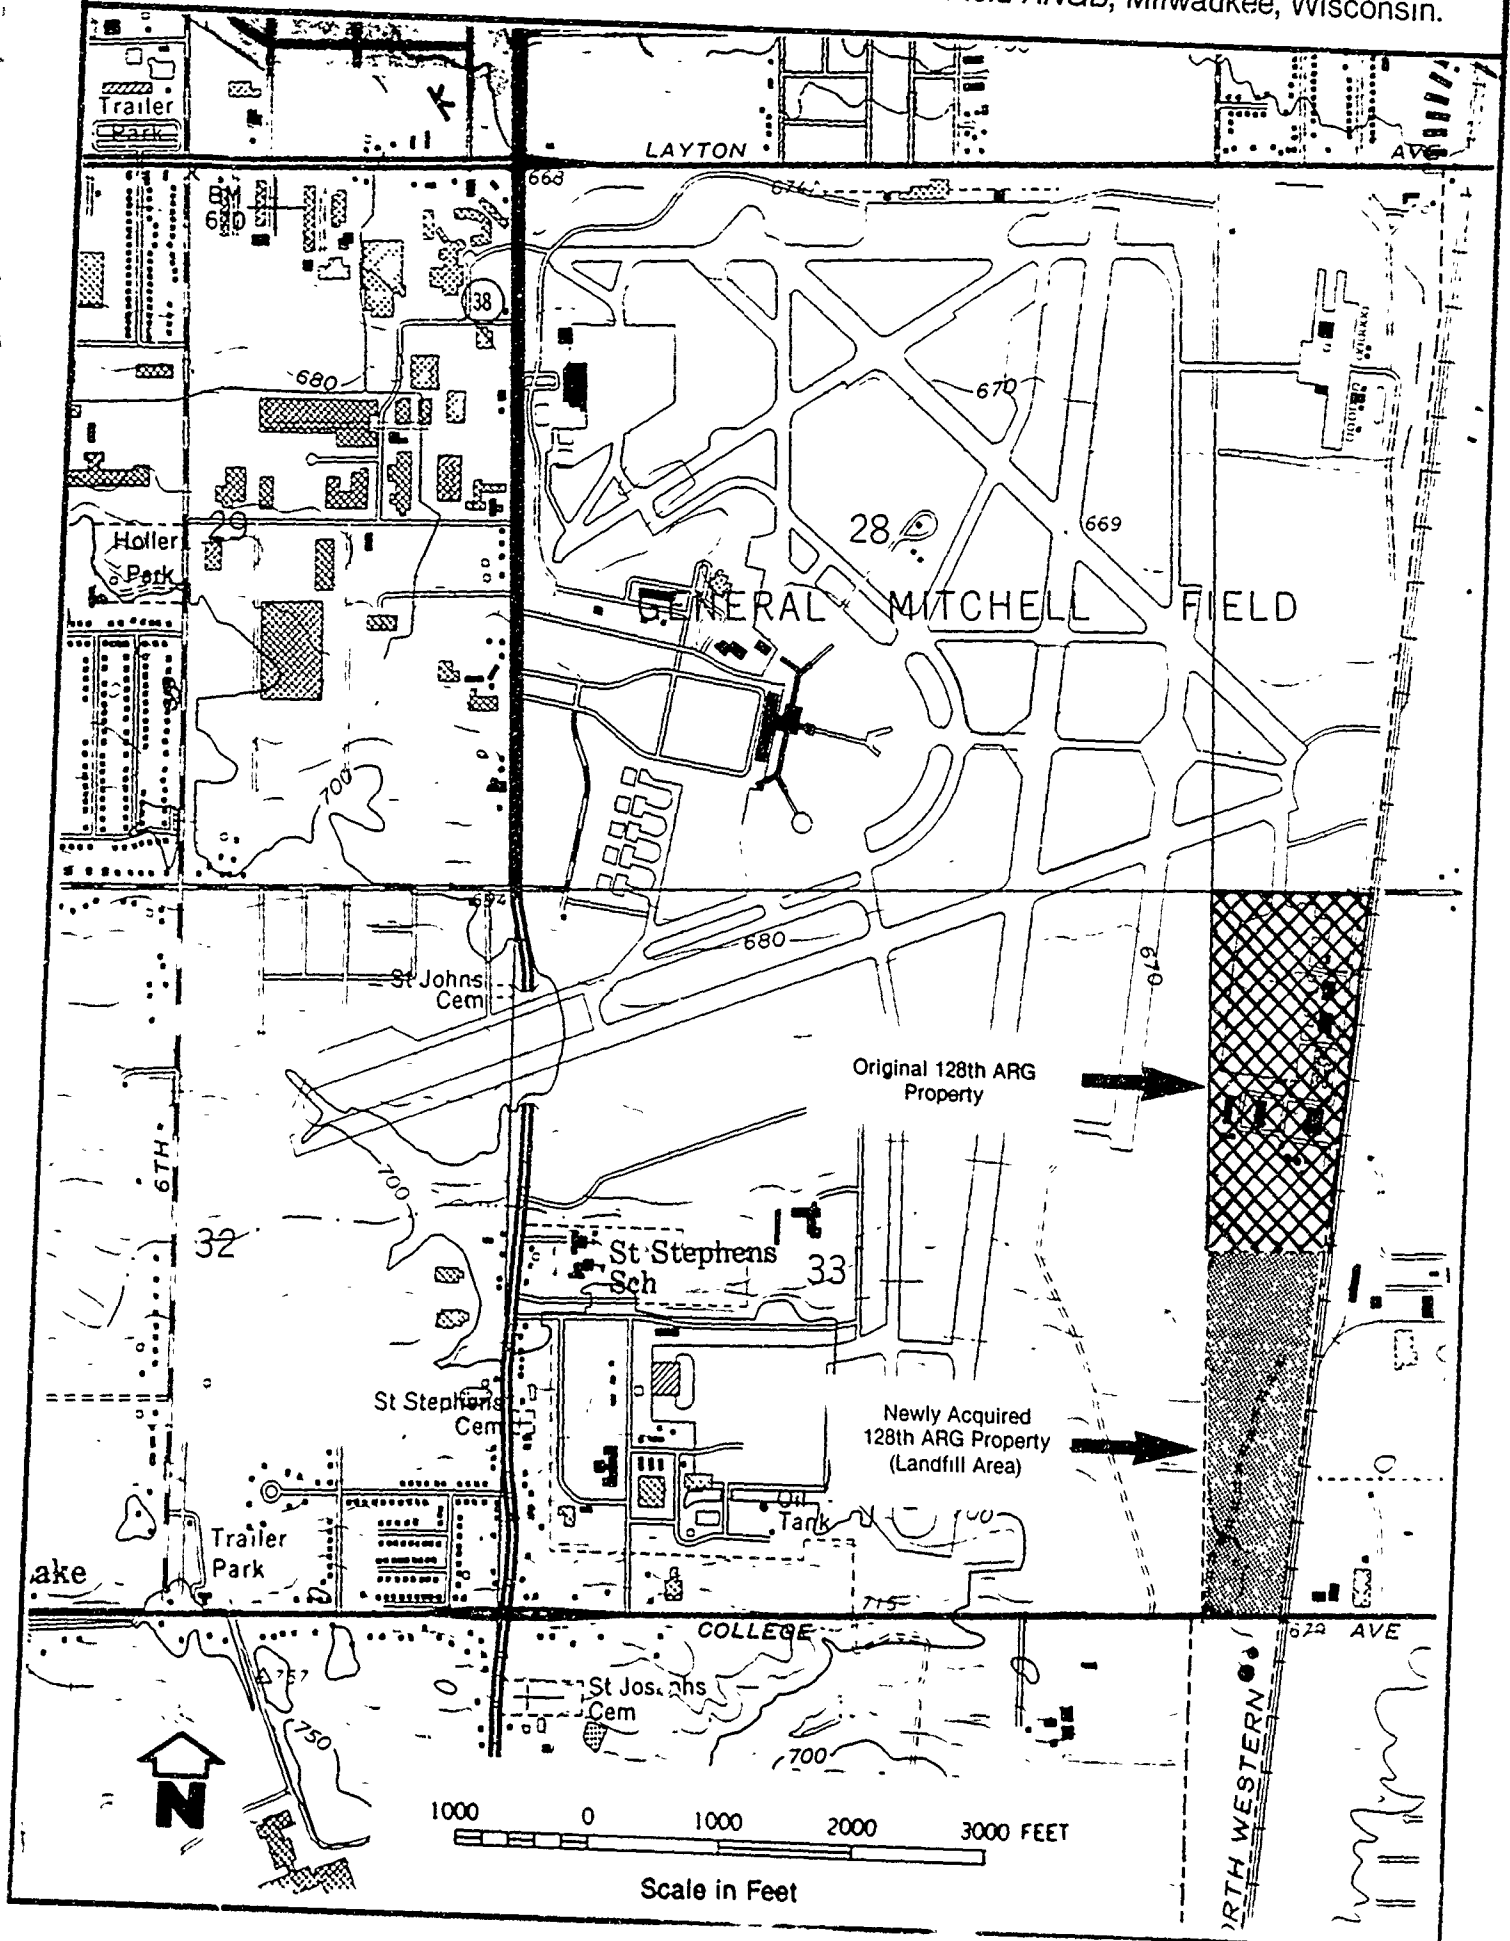
Figure 4.

In 1986, 128th ARG acquired a landfill previously owned by the City of Milwaukee. There is no evidence that the landfill was used as a sanitary landfill, or for disposal of hazardous wastes. As is indicated in Figure 4, the landfill is located between what was previously the southern border of the base, and College Avenue. Inquiries were made to the City of Milwaukee Health Department's Sanitation Section concerning the nature and history of the landfill. City records on the subject were sparse. City officials estimate that the landfill was in use prior to the 1940's until 1985. Types of materials disposed of in the landfill are reported to consist of cans, bottles, and scrap metals. In recent years, the site was used for road construction rubble and gravel disposal. The site was also used for

Newly Acquired Property at General Mitchell Field ANGB, Milwaukee, Wisconsin.

The 128th ARG has excavated several test pits at the landfill with backhoes. The excavations are to a depth of four feet. Materials unearthed are consistent at each of the excavations, consisting of bottles, rusted cans, plastic containers, gravel, concrete, and scrap metal. Earth in other areas of the landfill has been moved and graded in order to provide an entranceway to the 128th ARG. Materials revealed during the grading process were identical to those found in the test pits. Upon touring the landfill, HMTC saw no evidence of hazardous waste disposal from materials exposed on the surface. As there is no evidence that hazardous wastes have ever been disposed of at the landfill, HARM Scoring is not considered necessary, and no further action is required.
